# PROJECT PROFILE

## Medellín Coliseum

## Perfecting a Seamless Maple Wood Flooring Repair at Medellín Coliseum

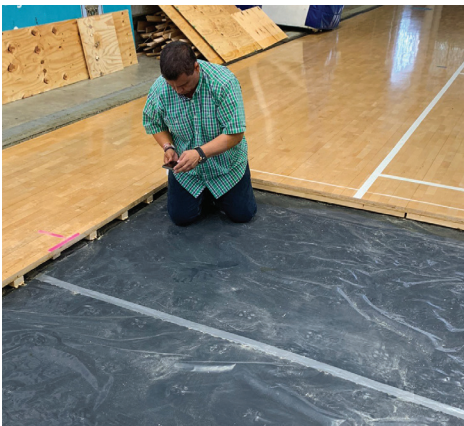
Although the maple sports flooring in the Coliseum was strong and durable, the heavy weight of the stage and lighting rigs would have damaged it. So, Uribe and his team had to get creative.

To accommodate the stage and lighting installation, Uribe and his team cut a series of holes into the existing maple flooring to have 100-ton ground support installed directly over the concrete.

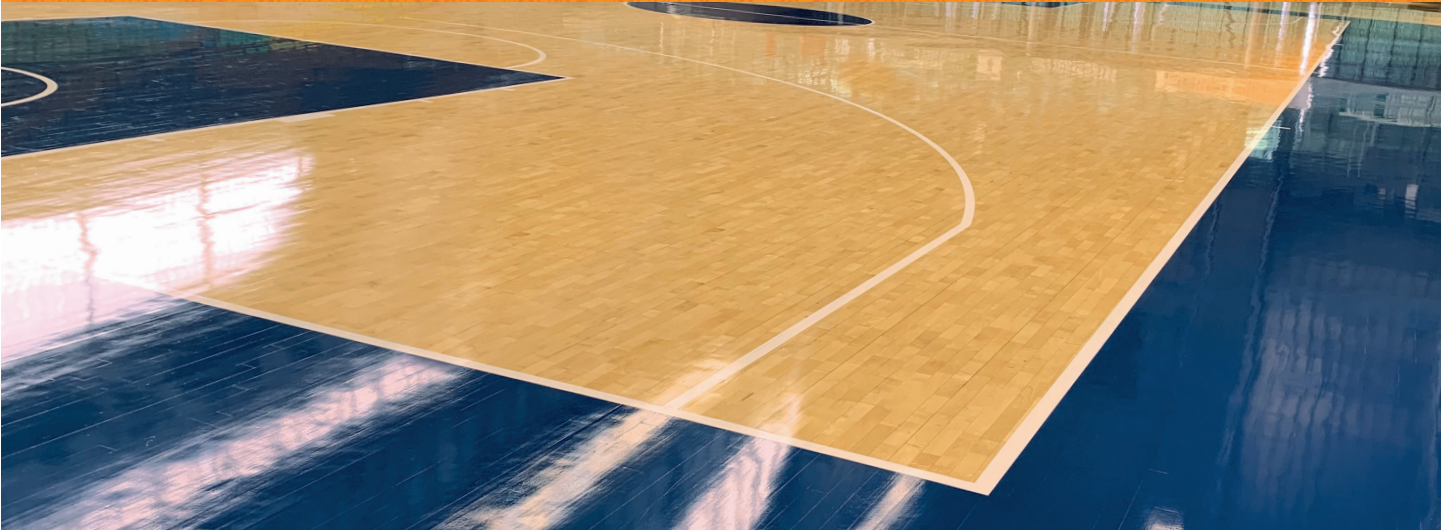
Ultimately, the goal for Uribe was to have a seamless flooring restoration and to have the floor appear as if no holes had been cut into it. As you can see in the picture above, this was accomplished. Although substantial parts of the flooring were removed and a massive stage was installed, the flooring shows no sign that it ever occurred there.

To make this project as seamless as possible, Uribe matched the exact wood type of the existing floor system, which they were able to source from Action Floors. Using 20x57mm pieces of MFMA Random Length (RL) Second and Better Grade Maple wood, the repairing and refinishing came together without any issues. Second and Better Grade Maple contains some variations in wood. So, if they would have replaced the flooring with a different grade, the replacement flooring would have looked noticeably different from the rest of the floor. Second and Better Grade Maple is also close-grained and hard-fibered, which helps keep it free from splintering and slivering. Matching this character of the wood was also important so that the wear over time would be consistent with the other flooring.

Using MFMA-graded wood helped keep a high level of performance quality throughout the entire floor once the replacement was finished.
